**SAIB:** 2022-20  
**Date:** October 19, 2022

**SUBJ:** Wing Spar

This Special Airworthiness Information Bulletin (SAIB) alerts all owners, operators, maintenance technicians, and inspectors of **Piper Aircraft, Inc. (Piper) PA-28 and PA-32** airplanes of information gathered as result of a fatal accident of a Piper Model PA-28R-201 airplane in 2018 and the inspection findings that followed. The accident, determined to be caused by fatigue cracks in the lower spar cap, resulted in the Federal Aviation Administration (FAA) issuing Airworthiness Directive (AD) 2020-26-16, which requires several actions including a one-time inspection of certain lower spar cap bolt holes. AD 2020-26-16 was issued as an interim action and requires reporting certain inspection information to the FAA to help determine the number of cracks present in the fleet. The inspection reports received by the FAA thus far indicate the presence of numerous cracks and hole-quality issues in a significant number of airplanes.

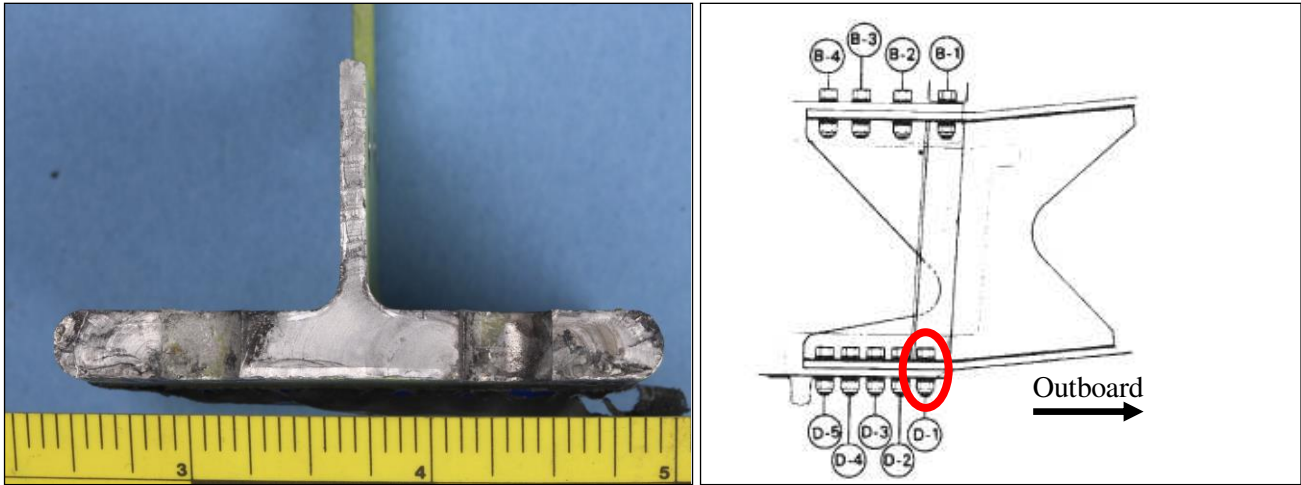
As stated above, the FAA issued AD 2020-26-16 due to a 2018 in-flight wing separation on a Piper Model PA-28R-201 airplane caused by fatigue cracks located in a visually inaccessible area of the lower main wing spar cap. Inspection of another airplane in the same fleet of the accident airplane (manufactured at a similar time and operated in a similar training mission) was also found to have cracking in the wing spar. The National Transportation Safety Board (NTSB) found fatigue cracking across an extensive cross-section of the lower spar cap. The crack and failure occurred across the T-section at the two most outboard bolt holes attaching the lower spar to the wing box (see Figure 1).

**Figure 1. Spar Cap Failure at Outboard Bolt Holes (left), Spar and Center Wing Attachment Configuration, Failure Location Shown (right)**

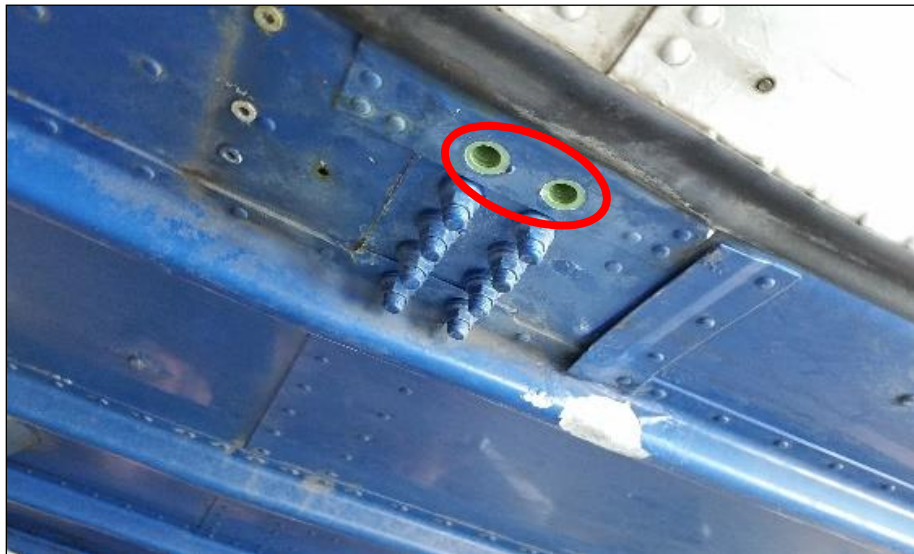
AD 2020-26-16 requires a one-time eddy current inspection of certain bolt holes of spars that have reached 5,000 factored service hours (FSH), and a reporting of the inspection results to the FAA and Piper. The inspections were required for the most outboard set of bolt holes, both forward and aft (see Figure 2). The eddy current inspection method is a non-destructive technique that utilizes electromagnetism to detect flaws on and under the surface of a part in question. The inspection method has certain limitations including the depth in the material where a flaw can be detected, the size of the flaw, and that a highly skilled and properly trained inspector is required, but it is a proven tool that is commonly used for inspections of this nature. The eddy current inspection method is capable of detecting cracks, but is also sensitive to surface anomalies that may cause cracks to form in the future, such as corrosion or gouges. Visual inspections are not sufficient to detect such cracks.

**Figure 2. Outboard Bolts Removed and Location of Inspection, RH Wing Root**

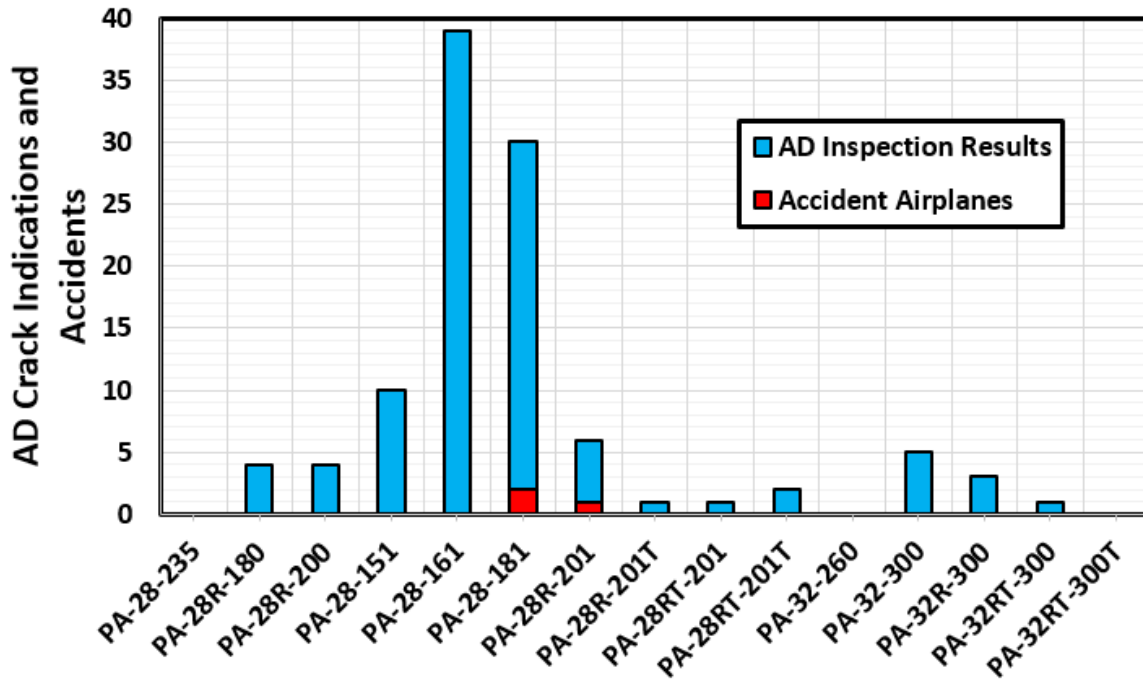
The FAA and Piper received reports on approximately 2,880 airplanes. Out of these, 115 airplanes were reported as having crack indications. Approximately 25 percent of these indications were later confirmed to be hole damage or corrosion and not a crack. The remaining indications include a mix of unconfirmed indications, but fatigue cracks were also identified, including some examples shown in this SAIB. Unconfirmed crack indications were found in airplanes with as little as 3,264 hours time in service (TIS) on a Piper Model PA-28R-180 airplane, but has not yet been confirmed. Figure 3 shows a summary of the positive indication inspection results received by the FAA and airplane models involved in accidents attributed to or potentially related to the spar cracking issue. In addition,

**Figure 3. AD Inspection Crack Indications\* and Related Accidents**

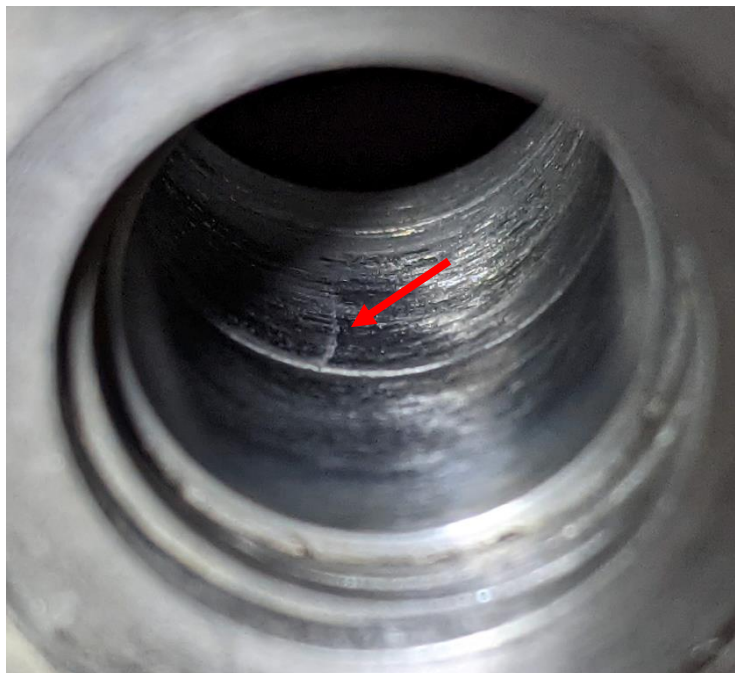
**Figure 5. Example of Cracks Intersecting Bolt Hole, After Corrosion Removal  
PA-28-161, 9,036 hours TIS**

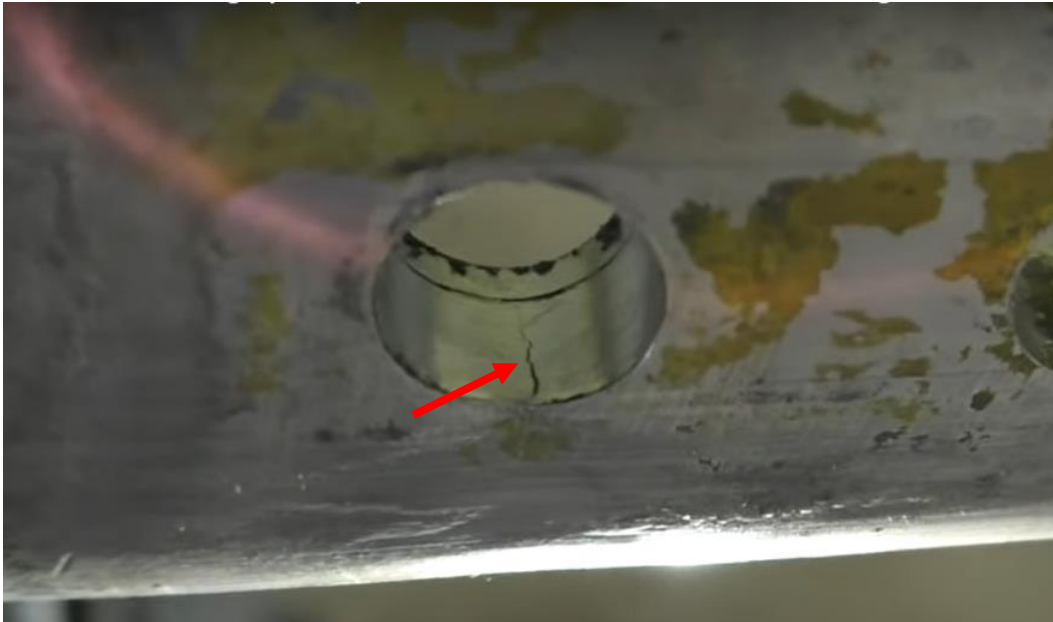
**Figure 6. Example of Cracks Intersecting Bolt Hole  
PA-32-300, 5,319 hours TIS**

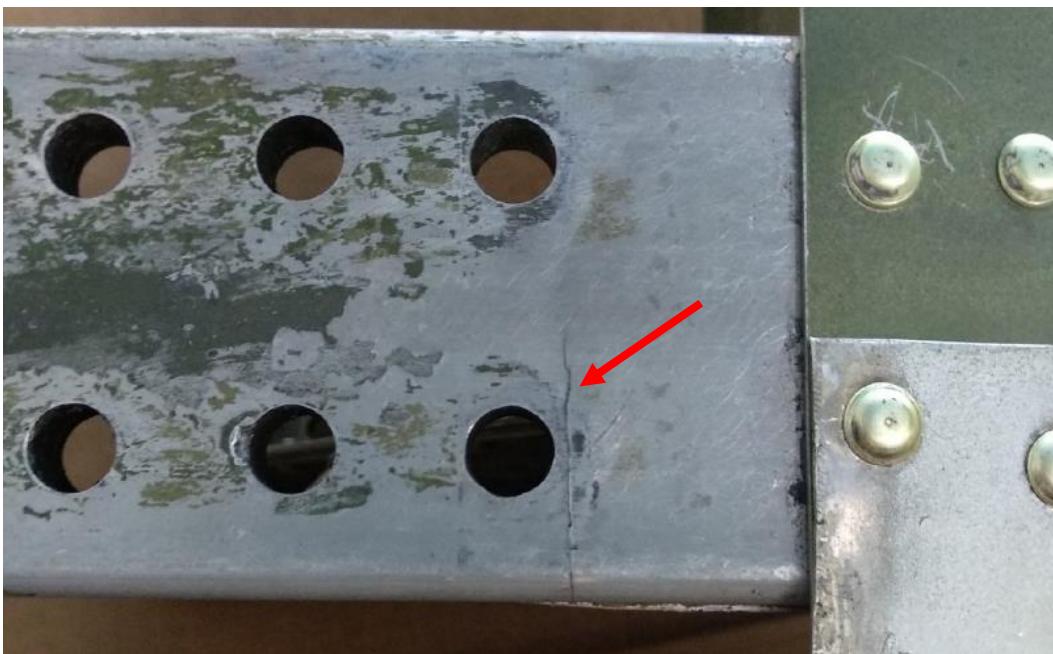
**Figure 7. Example of Cracks Not Intersecting Outboard Bolt Hole  
PA-28-181, 12,824 hours TIS**

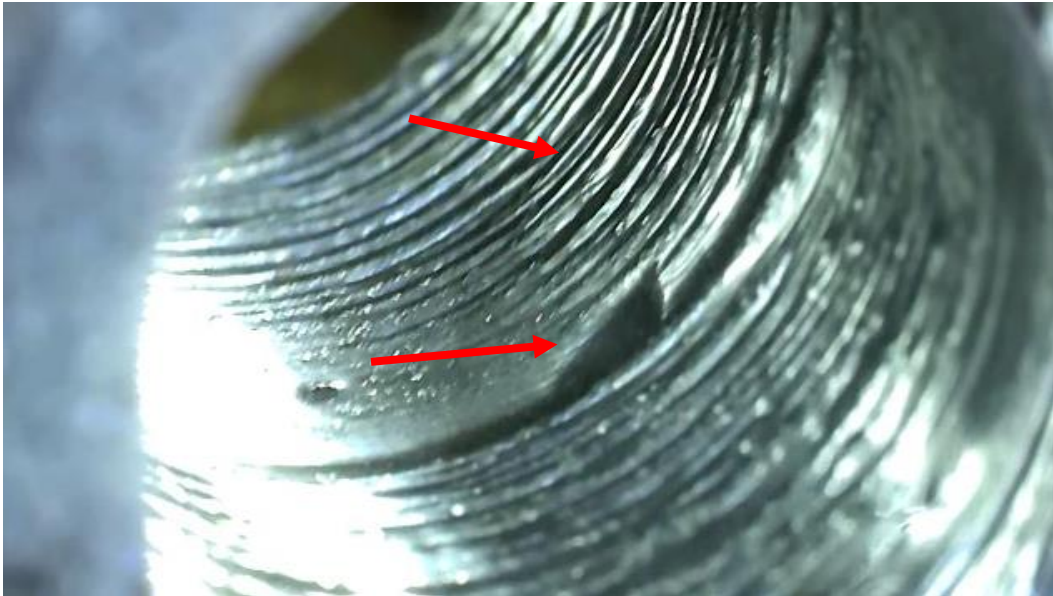
**Figure 8. Example of Mechanical Bolt Hole Damage, No Crack  
PA-28-181, 2,533 hours TIS**

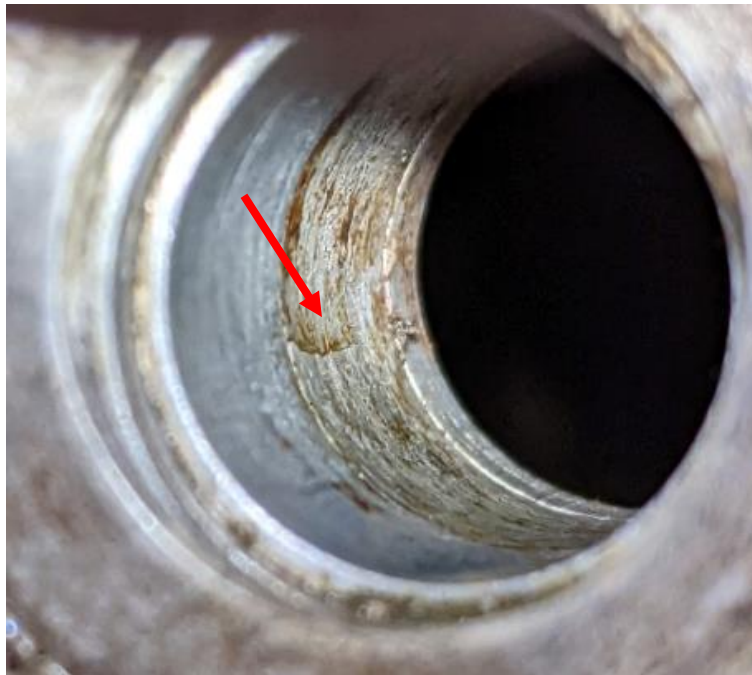
**Figure 9. Example of Corrosion in Bolt Hole, with Crack  
PA-28-161, 9,036 hours TIS**

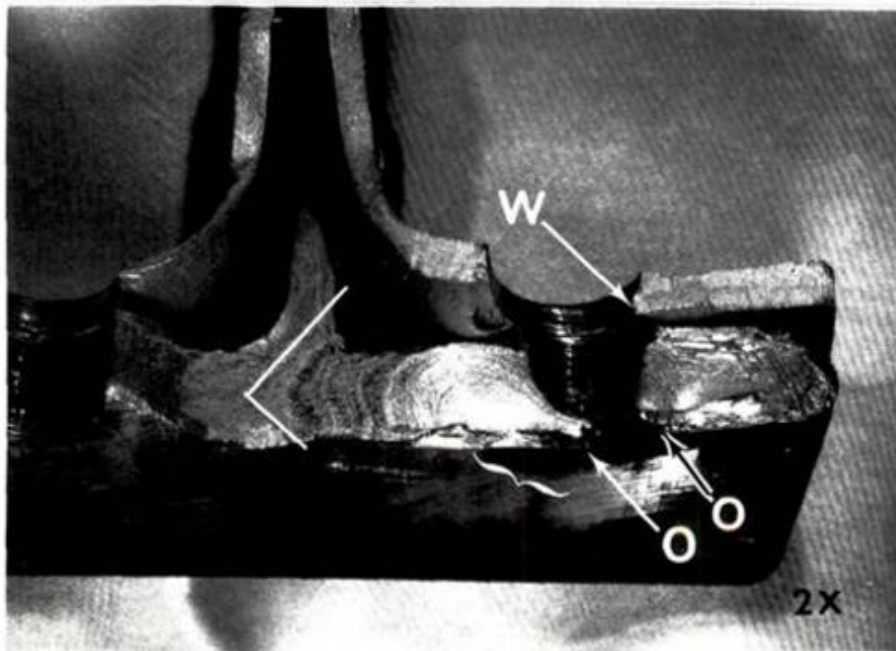
The first related accident occurred in 1987 in Marlin, TX. The accident airplane was a Piper Model PA-28-181 airplane with 7,490 hours TIS. Nearly all of this airplane's flight time was known to be spent in a "Pipeline Patrol" mission. This type of mission is characterized by very low altitude and terrain following flight profiles. These flying characteristics degrade an aircraft's structure faster than most other missions. See Figure 10 for a view of the accident airplane's failed spar, where "O" indicates fatigue crack origins and "W" indicates a web fatigue crack.

**Figure 10. 1987 Accident, Failed Wing Spar  
PA-28-181, 7,490 hours TIS; O indicates crack origin**

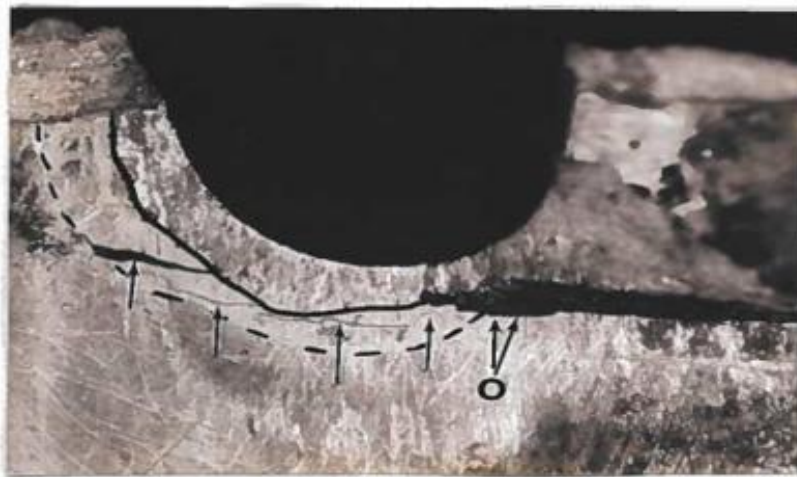
The second of these accidents occurred in 1993 in Provincetown, MA. The accident airplane was a Piper Model PA-28-181 airplane with 11,683 hours TIS. This accident was attributed to weather with signs of structural overloading, but a fatigue crack was also found in the failed spar. The crack is beyond the critical crack size later calculated for that spar. While the NTSB did not identify the fatigue crack as the probable cause of the accident, its presence may have contributed to the effect of the structural overload. At the time of the accident, the airplane was being flown for personal use; however, the airplane was operated by a company providing a mix of training and charter flights. The training mission type of flying is characterized by low altitudes and many takeoff and landing cycles. While less severe than a “Pipeline Patrol” mission, the training mission would contribute more towards fatigue than personal use. See Figure 11 for a view of the accident airplane’s failed spar near a bolt hole, where “O” indicates fatigue crack origins. The origin in this case was adjacent to the hole, not in the hole, as in the 2018 accident.

**Figure 11. 1993 Accident, Failed Wing Spar  
PA-28-181, 11,683 hours TIS; O indicates crack origin adjacent to the bolt hole**

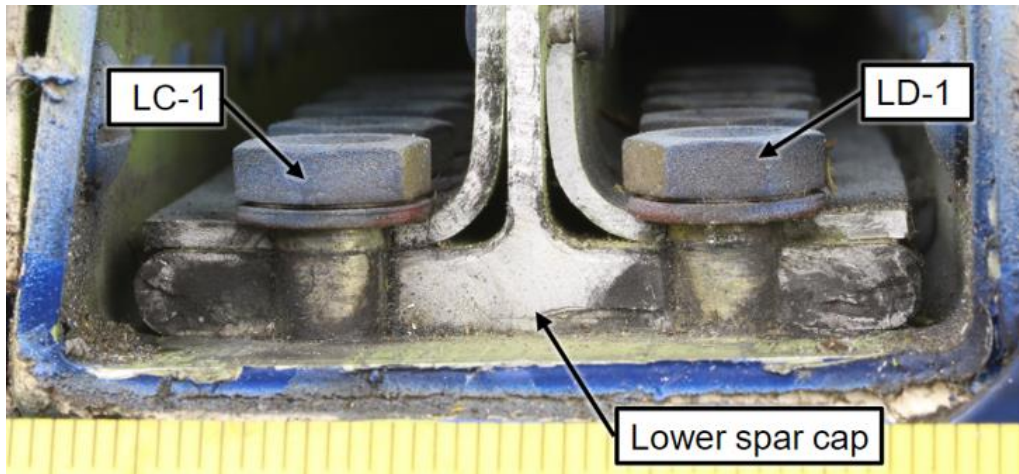
The third and most recent of these accidents occurred in 2018 in Daytona Beach, FL. The accident airplane was a Piper Model PA-28R-201 airplane with 7,691 hours TIS. This airplane was used almost exclusively for flight training throughout its lifetime. This type of usage is expected to reduce the fatigue life of the airplane more than an airplane used as a mixture of personal and training, while still less damaging than use exclusively in the “Pipeline Patrol” mission. See Figure 12 for a view of the accident airplane’s failed spar.

**Figure 12. 2018 Accident, Failed Wing Spar  
PA-28R-201, 7,691 hours TIS**
